2020 WESTERN LEHIGH INTERCEPTOR MANHOLE REHABILITATION PROJECT

PROJECT HISTORY & CURRENT DEVELOPMENT

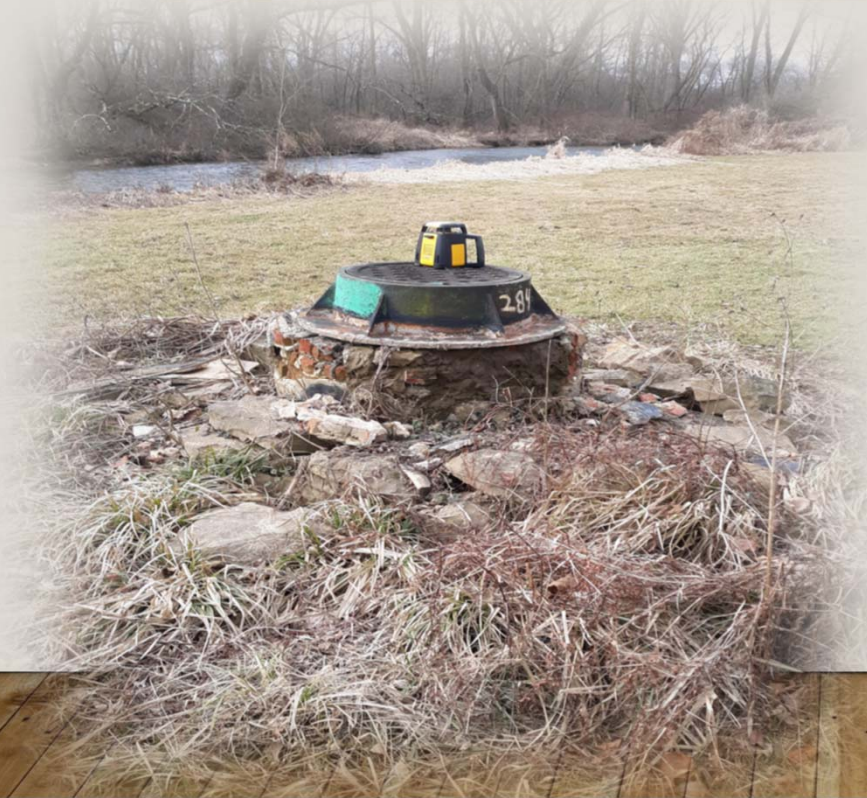
ID: L284

**LOCATION: SPRING CREEK
ROAD, LOWER MACUNGIE**

IMPACT HEIGHT: 2 FOOT

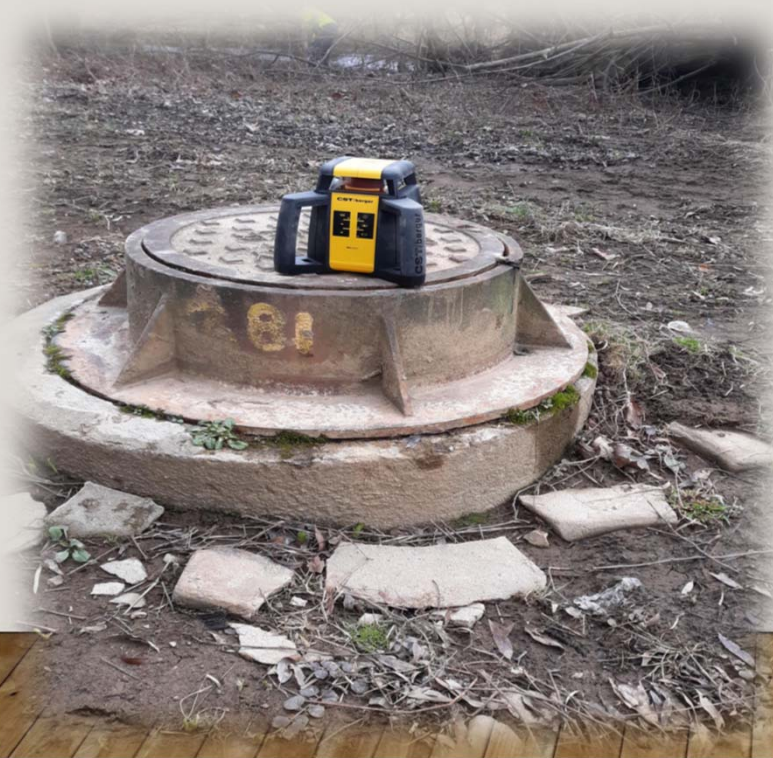
ID: L281

**LOCATION: SPRING CREEK
ROAD, LOWER MACUNGIE**

IMPACT HEIGHT: 2 FOOT

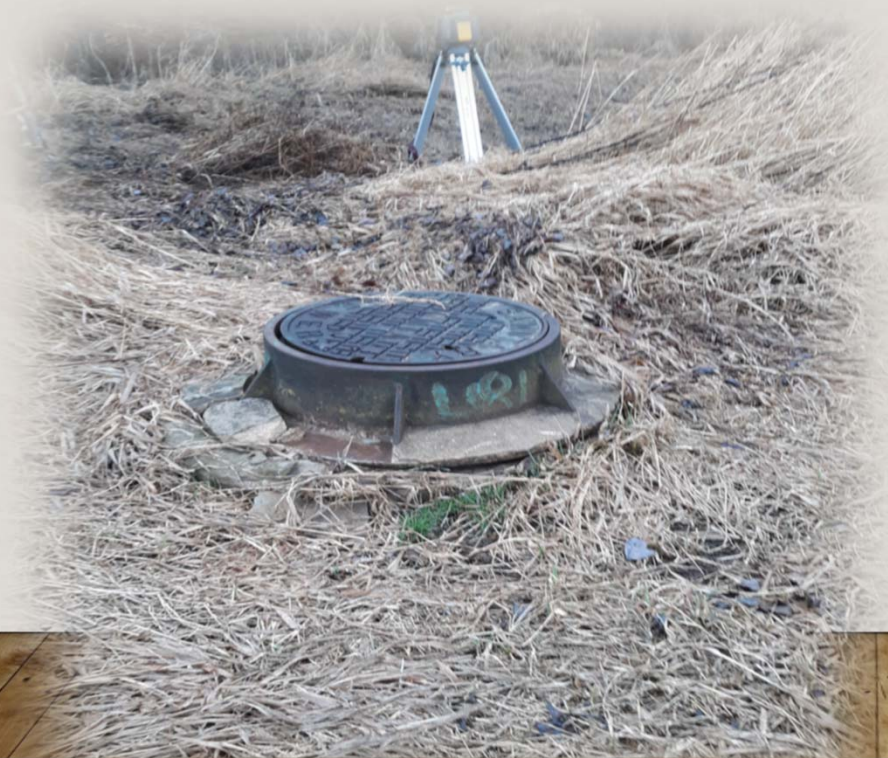
ID: L181

**LOCATION: CHURCH
STREET, ALBURTIS**

IMPACT HEIGHT: 1 FOOT
