### *Park Pump Station Force Main Inspection Report*

Park Force Main Internal Inspection  
from ARVs 4, 5, and 6

December 22, 2021

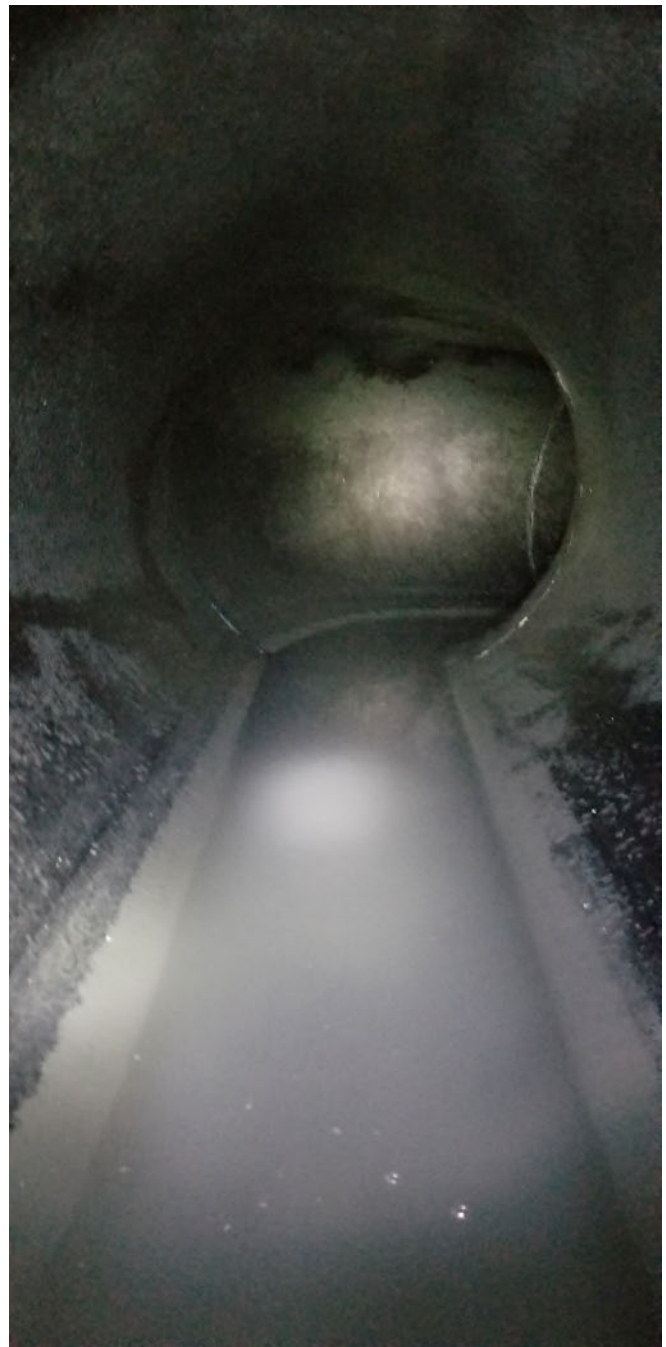
Manned entry inspection was conducted to approximately 40' upstream of ARV 4. The coating is firmly bonding to the mortar. Hammer sounding indicates the cylinder-mortar bond is still good.

*Figure 6 - ARV 4 toward ARV 5 - 10' downstream looking at bend at Station 2724*

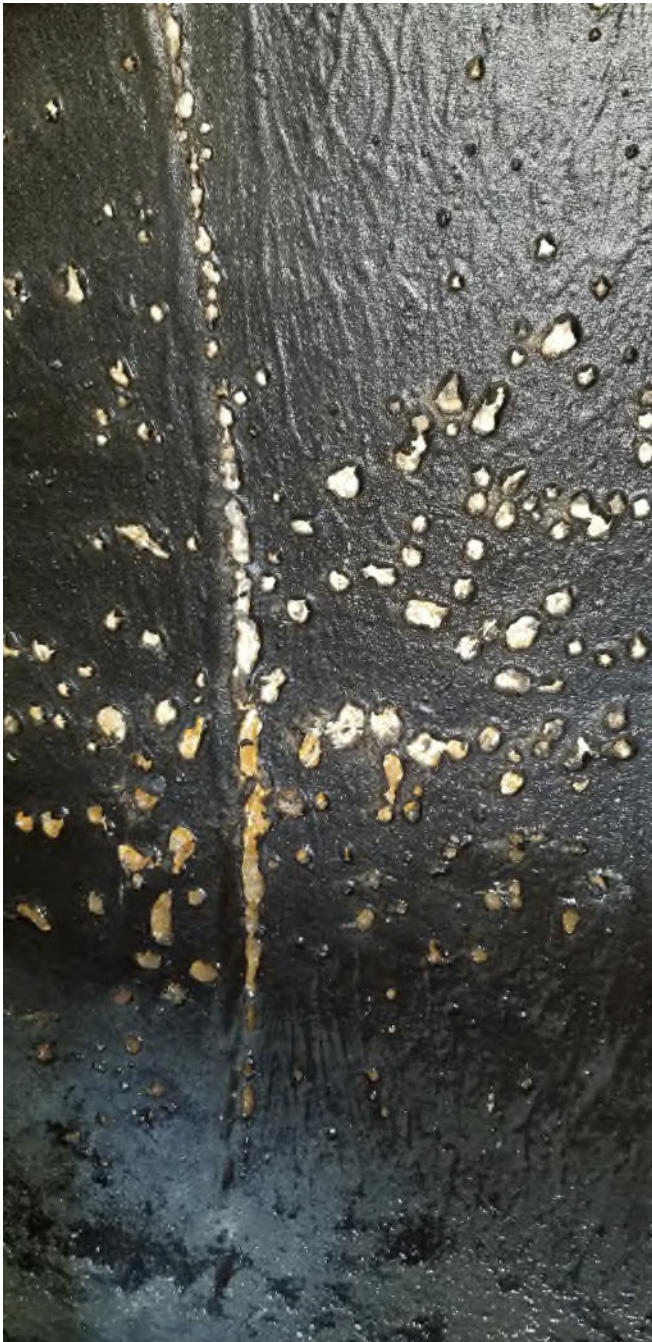
Man entry inspection was conducted to approximately 40' upstream of ARV 6. The coating is blistered and disbonding from the mortar above the pump off water line, first in bands between the 2-4 and 8-10 clock positions, then extending from 8-4 clock positions. Within the length inspected via man entry, there is  $\sim\frac{1}{4}$ " mortar loss under the blistered coating. The CCTV further upstream is hazy but blistering and H<sub>2</sub>S attack looks similar to what was seen ARV 5 toward ARV 6, though the mortar loss is measurable but less than  $\frac{1}{2}$ ". The coating is thin and brittle where it is flaking off. The H<sub>2</sub>S attack under the coating is wide-spread. Hammer sounding indicates the cylinder-mortar bond is still good .

*Figure 22 - ARV 6 toward ARV 5 - Coating Blisters and Disbondment*

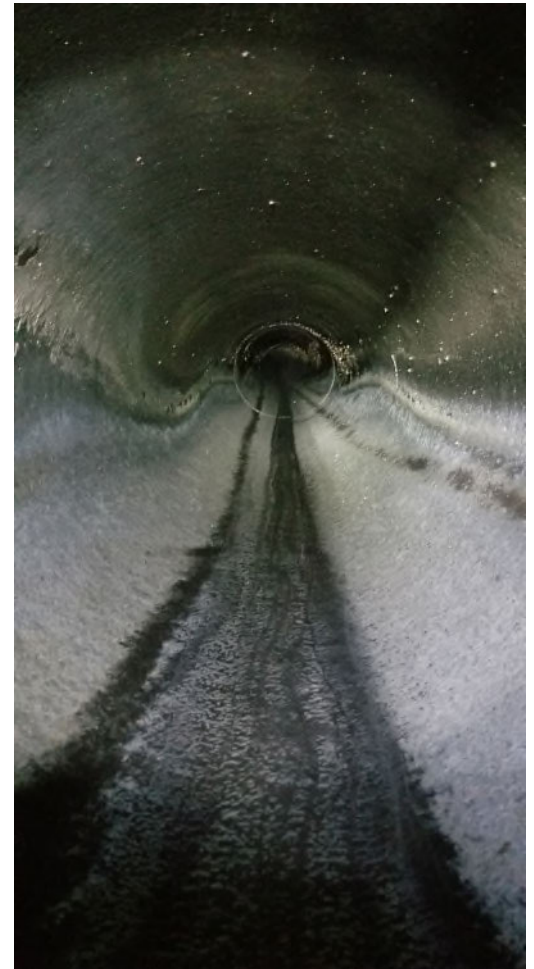
Man entry inspection was conducted to approximately 30' downstream of ARV 6. The coating is blistered and disbonding from the mortar above the pump off water line between the extending from 8-4 clock positions. The mortar behind the blisters is soft. Hammer sounding indicates the cylinder-mortar bond is still good .

*Figure 23 - ARV 6 toward ARV 7 - Pipe*

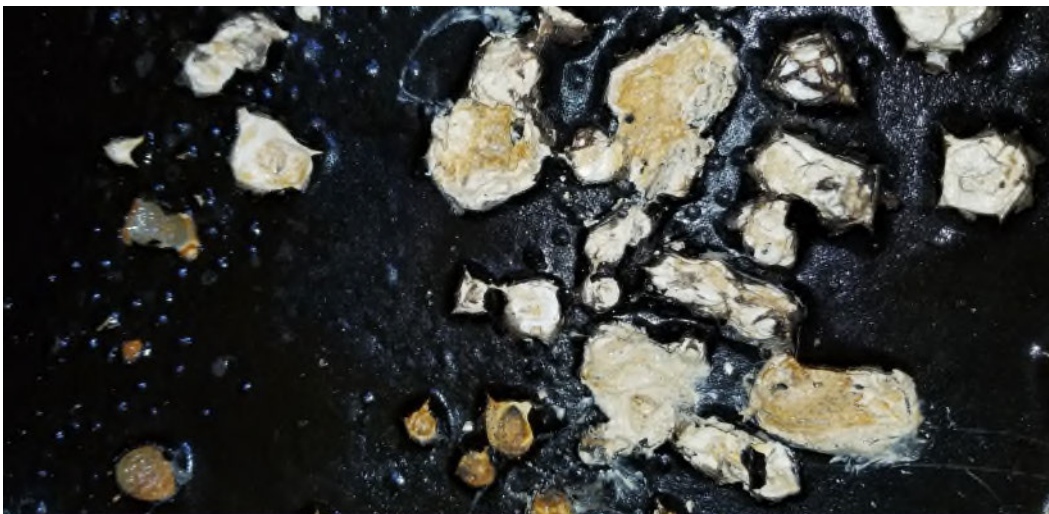
*Figure 24 - ARV 6 toward ARV 7 - Blisters in Coating*

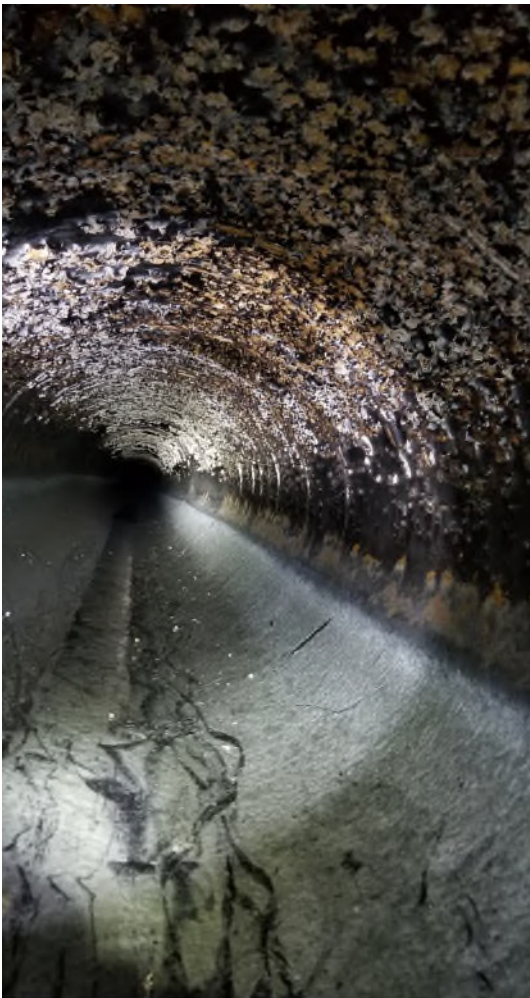
Manned entry inspection was conducted to approximately 80' upstream of ARV 8. The coating and pipe below the water line is sound. Above the waterline, the black coal tar coating is blistered the entire length inspected. Upon probing with mason's hammer, the cement liner under the coating pock marked and generally soft to a depth of 3/8" to 1/2" deep. There are no places where the coating and mortar are completely stripped away. The H2S attack under the coating is wide-spread. Where the mortar is exposed, it is still yellow but relatively hard. Hammer sounding indicates the cylinder-mortar bond is still weakening at various clock positions depending on the station of the pipe.

Figure 26 - ARV 8 toward ARV 7 - Blisters in Coating

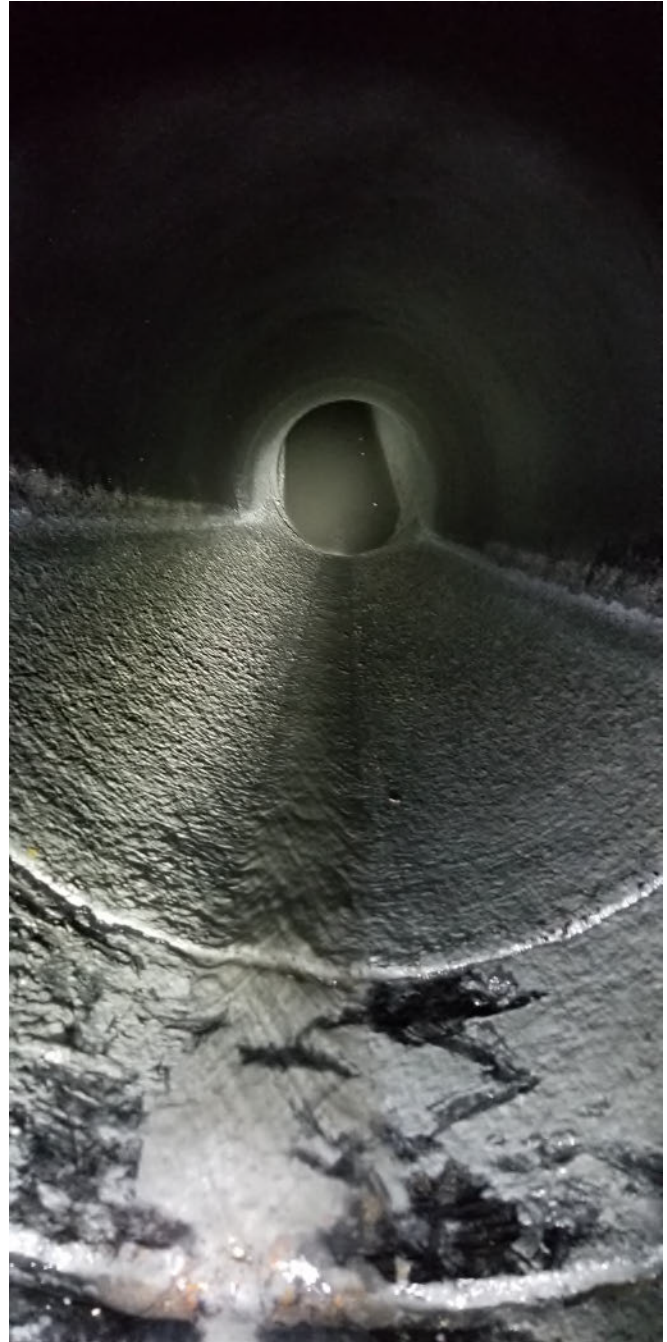
The coating and pipe below the water line is sound. Above the waterline, the black coal tar coating and mortar are sound and without significant defects visible.

*Figure 32 - ARV 9 - Access Chamber 2*

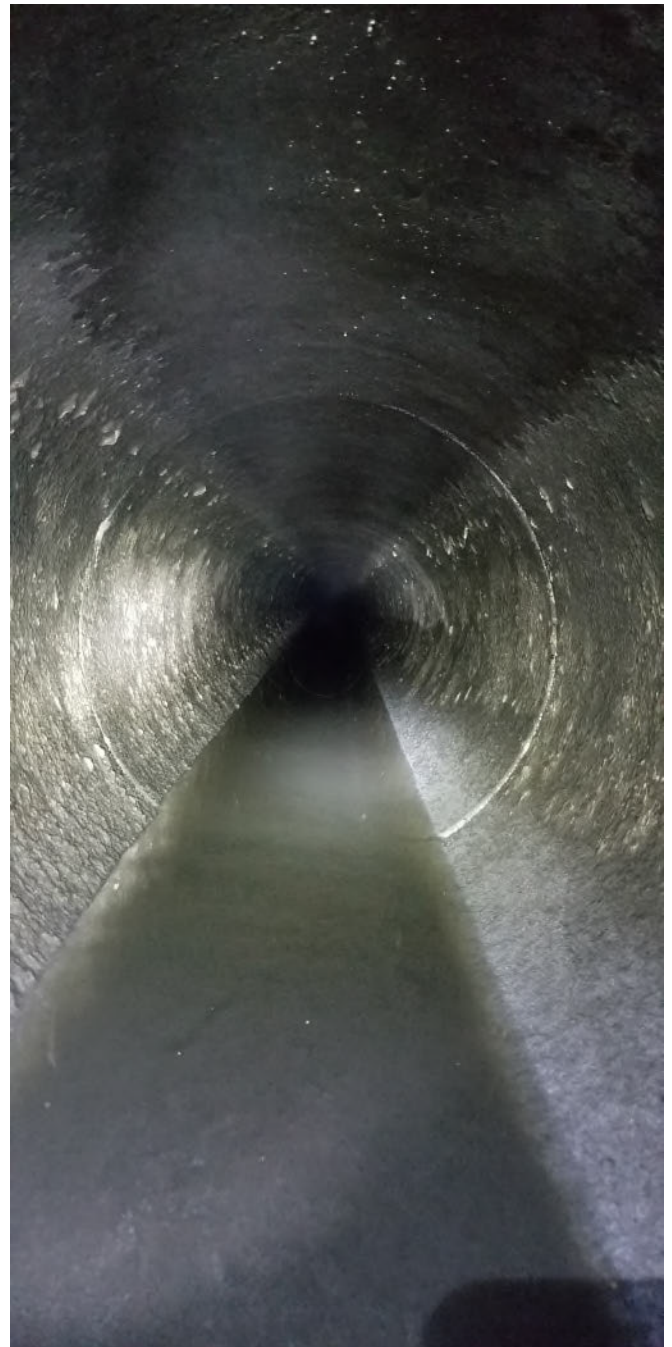
Manned entry inspection was conducted to approximately 40' downstream of AC2. The coating and pipe at this location are in good shape with minimal/no degradation of the coating or the underlying pipe cement mortar coating. Hammer sounding indicates the cylinder-mortar bond is sound.

*Figure 34 - AC2 - PRV 10*
