2020 WESTERN LEHIGH INTERCEPTOR MANHOLE REHABILITATION PROJECT

PROJECT HISTORY & CURRENT DEVELOPMENT

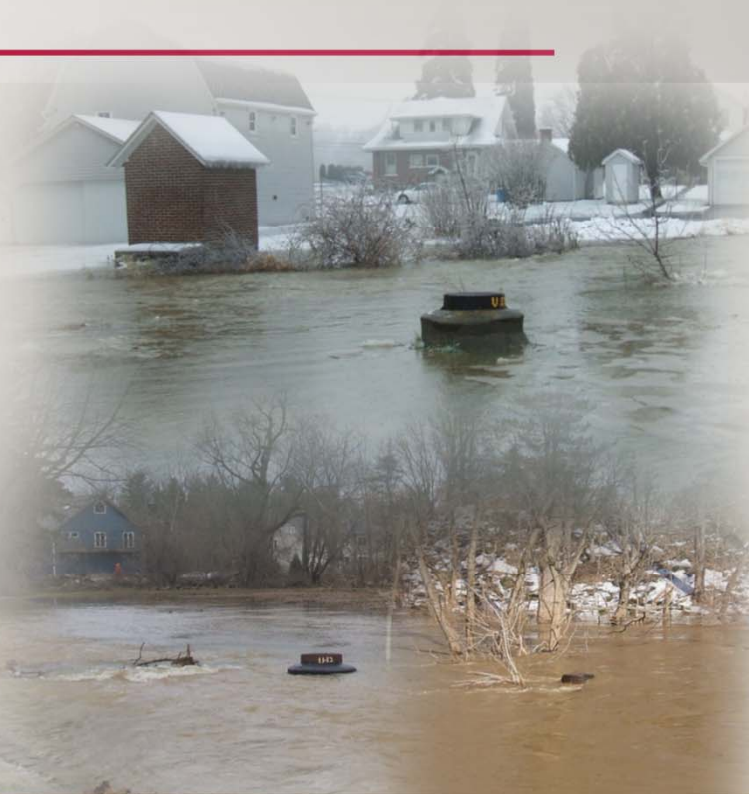
CAPITAL WORKS CREEK ELEVATION ANALYSIS

Our analysis indicated, by evaluating historic and real time changes of creek elevation since 2016. The following flooding events outlined below would have the potential impact to the system.

- With a 1 foot rise 3 manholes were inundated 71 times.
- With a 2 foot rise 31 manholes were inundated 38 times.
- With a 3 foot rise 92 manholes were inundated 20 times.
- With a 4 foot rise 197 manholes were inundated 10 times.
